MF01-50

(WITH EXPOSED HINGES)

A luxurious grand entrance door with superior functionally and aesthetics.

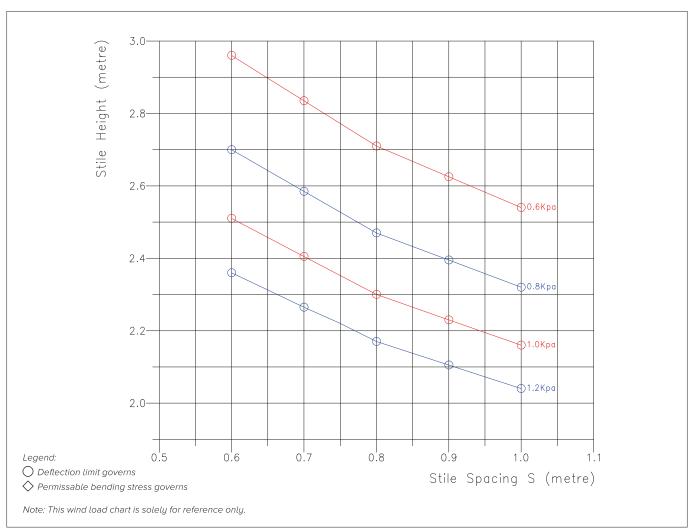
Wind Load Chart

Mullion Section No. : 6002(x2) : 69 x 10⁹ n/m² Mod. of Elasticity

Aluminium Alloy : 6063 - T5 Deflection Limit : Span/175 up to max. 20 mm

Moment of Inertia Ixx: 30.4 cm4 : 1.25 x 67 Mpa Perm. Bend. Stress

(within slenderness limit) Mod. of Inertia Zxx : 14.4 cm³

Nature of Anchor : Simply Supported at Both Ends

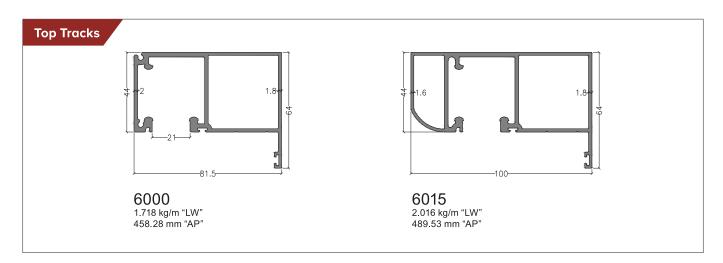
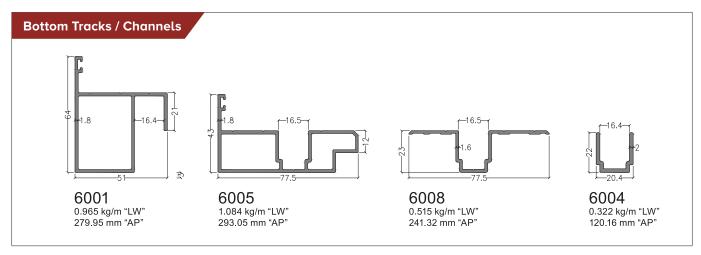
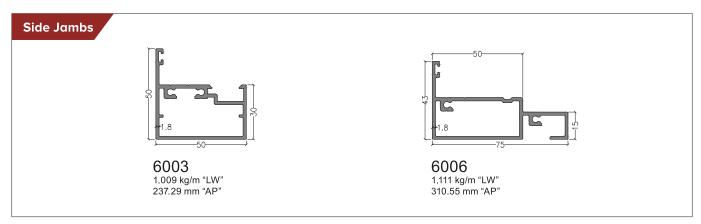
Sectional Details

Inner Frames 6002 1.475 kg/m "LW" 325.12 mm "AP" Ixx: 29.2 cm⁴ Iyy: 15.2 cm⁴ 6020 1.055 kg/m "LW" 328.72 mm "AP" Ixx: 22.4 cm⁴ Iyy: 10.5 cm⁴ 6018 1.430 kg/m "LW" 327.95 mm "AP" 6016 1.361 kg/m "LW" 400.85 mm "AP" 6007 1.828 kg/m "LW" 428.18 mm "AP" lxx: 69.6 cm⁴ lyy: 21.1 cm4 **Glazing Beads Overlap Wing Attachment** 6017 (For 6016) 0.222 kg/m "LW" 161.77 mm "AP" 6019 (For 6018) 0.117 kg/m "LW" 88.84 mm "AP" 6038 6040 0.384 kg/m "LW" 219.88 mm "AP" 1.369 kg/m "LW" 326.15 mm "AP"

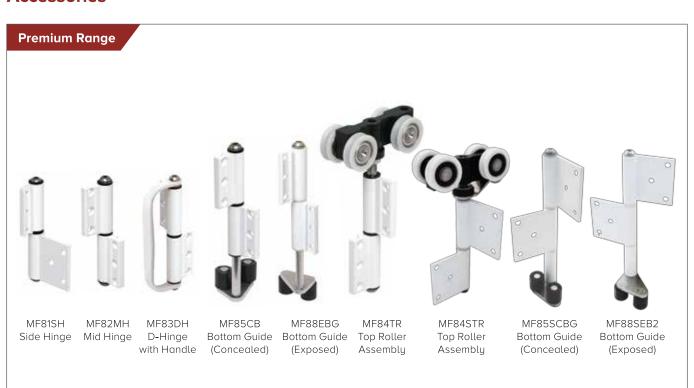
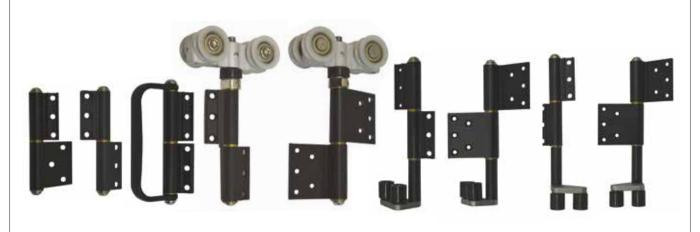
Accessories

MF61SH Side Hinge

MF62MH Mid Hinge

MF63DH D-Hinge with Handle

MF64TR1 Top Roller (Mid Hinge)

MF64STR Top Roller (2+2 Hinge)

MF65CBG Bottom Guide (Concealed)

MF65SCBG Bottom Guide (2+2 Hinge Concealed)

MF68EB2 Bottom Guide (Exposed)

MF68SEB2 Bottom Guide (2+2 Hinge Exposed)

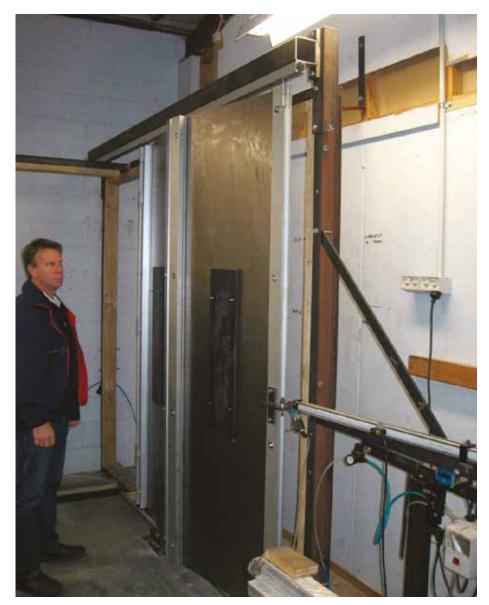
Rollers and hinges tested to 50,000 times open/close cycles

Picture 2: General arrangement of test unit (note photos after testing 25,000 cycles). Door just before the closed position.

Picture 1: Top rollers in position

Picture 2: Mid-hinge (Opened position)

Picture 3: Sand and grit applied into bottom (33,000 cycles)

Zebratti hardware was mounted on a 2 panel bi-fold door approximately 2400mm high x 1700mm wide. This was mounted in the test frame. The test frame is a mild steel rig capable of supporting the door in a similar manner to the onsite. The test frame is inside AES factory.

Each door panel is approximately 2300mm high x 820mm wide, infill panels are mild steel plate. The total weight of each panel is 80kg.

The doors were still operating correctly after 25000 cycles with no significant change in door operation. There was some wear to plastic tyres with plastic tyre particles deposited on the chassis (see pic 1). There was no visible wear to the bottom quide roller.

Testing was continued up to 33000 cycles, there was no change in the operation at the time sand and grit were added to the bottom track. A check at 37000 cycles showed some of the grit had become embedded in the bottom guide and on the guide sides. This did not appear to affect operation, but created an increase in bottom guide noise.
